# Anti-Impact and Anti-Tear Series for Severe Operating Conditions

# BTW Impact Resistant Conveyor Belt

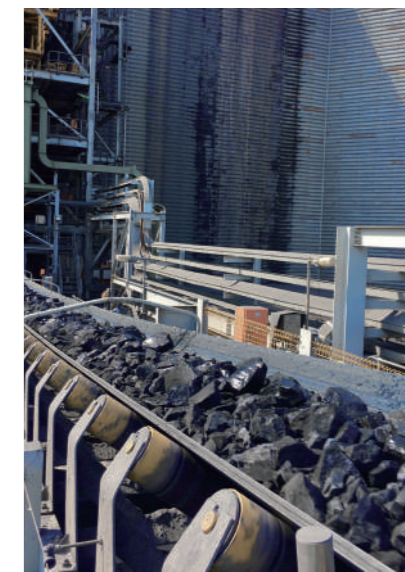
Item	HG/T3646 Standard	
	A	B
Cut Resistance/kN	≥3.0	≥10.0
Impact Penetration Strength/N·m	≥400.0	≥1000.0

HG/T3646-2014 Technical Specification for Anti-Tear Conveyor Belts systematically evaluates the conveyor belt's resistance to damage under complex working conditions from two dimensions: cut resistance and impact penetration strength.

- The cut resistance index is determined by a standard blade cutting test, simulating the material's ability to resist crack propagation when subjected to slitting or cutting by foreign objects.
- The impact penetration strength index is determined by a falling mass impact test, reflecting the material's ability to resist damage or penetration of the carcass caused by sudden external impact while the belt is under tension.

Both tests set detailed requirements for sample preparation, testing equipment, operating procedures, and data processing. For example, the specimen length must meet a 400 mm effective section, the cutting tool must match the belt carcass reinforcement material, the falling mass impact energy covers the 100 to 3000 N·m range to encompass common operating conditions, and a force-time curve must be recorded to assist in determining if internal damage has occurred.

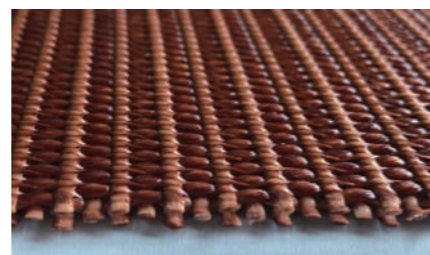
The BTW super heavy-duty carcass uses high-strength polyester and nylon as base materials, employing BOTON's independently developed BTW Triple Weave structure. It features both high elasticity and high strength, which significantly enhances the belt body's ability to absorb and disperse impact while improving transverse tear resistance. It is an anti-damage fabric carcass customized for high-impact conveying environments.

Unique Triple Weave structure utilizes high-strength polyester warp and nylon weft yarns. The upper and lower weft layers are woven into bundles with the main warp yarns, enhancing the carcass ply consistency and compressive elasticity. Characterized by high fabric density and strong adaptability, the conveyor belt consists of no more than 3 plies and is compatible with single or double-layer finger splicing as well as mechanical fasteners.

The BTW fabric carcass has a tight structure and features a triple weft layer structure. It has excellent elasticity and high-efficiency impact absorption capability, significantly reducing damage such as carcass rupture or breakage caused by materials dropping onto pulleys during loading or reclaiming.

The tightly woven structure strengthens transverse support, enhancing overall tear resistance and effectively suppressing structural damage caused by sharp material impact.

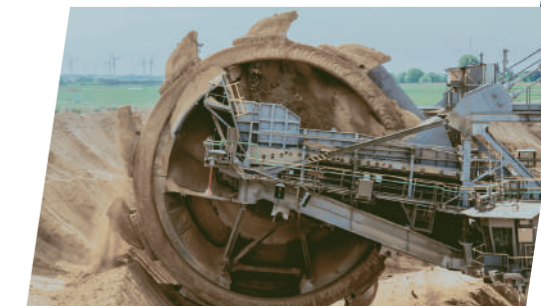
A cantilever belt conveyor at a certain stockyard had been using a standard EP fabric carcass conveyor belt for a long time. Due to complex operating conditions on-site, including wide belt width, large troughing angle, and frequent heavy material impact, the conveyor belt frequently experienced issues such as inter-ply delamination, premature fatigue cracking, and troughing deformation. The actual service life was less than half of the design expectation, resulting in high belt replacement frequency, significantly increased maintenance costs, and multiple unplanned downtimes severely affecting system continuity and production efficiency. The customer urgently required a customized solution specifically designed for cantilever systems, featuring high impact resistance and stable troughing capability.

Dimension	Standard Conveyor Belt	BTW Conveyor Belt
Downtime Frequency	Frequent downtime, frequent maintenance	Unscheduled downtime significantly reduced
Adaptability	Vulnerable to bending, limited curvature	Good small curvature adaptation, no large bending fatigue
Impact Resistance	High-speed material drop easily damages carcass	Good impact absorption, more durable structure
Troughing and Tracking	Prone to tracking deviation, poor stability	Excellent troughing capability, smoother conveying
Annual Operation and Maintenance Cost	High O&M costs, large downtime losses	O&M costs significantly reduced, system operates continuously

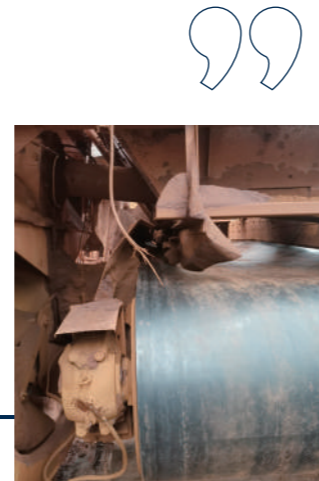
A mine project belonging to a leading SOE group in China's steel and metallurgy industry requires that, after mining, large blocks of ore undergo a crushing process. These ore pieces, which are often >300mm, typically drop onto the conveyor belt from a height of 4-6 meters, generating enormous instantaneous impact force that can easily puncture or tear the conveyor belt.

To address the characteristics of high-impact materials at the site, BOTON provided the BTW Impact Resistant Conveyor Belt, which features excellent cushioning performance and superior impact resistance, effectively extending the service life in this critical process. In this project, the customer's original 8-ply NN300 conveyor belt was typically punctured by the high-velocity impacting ore within 5-7 months. After switching to BOTON's 2-ply BTW Impact Resistant Fabric, the conveyor belt's service life was extended to more than 18 months, achieving significant results and substantially reducing maintenance costs.

Application Scenario	Original Solution (NN300 8-ply)	Improved Solution (BTW Impact Resistant Fabric)
Large Particle Size Ore Conveying 4-6 meter Drop Height	Service Life: 5-7 months Prone to Puncture	Service Life: Over 18 months Significantly Impact Resistant, Anti-Puncture

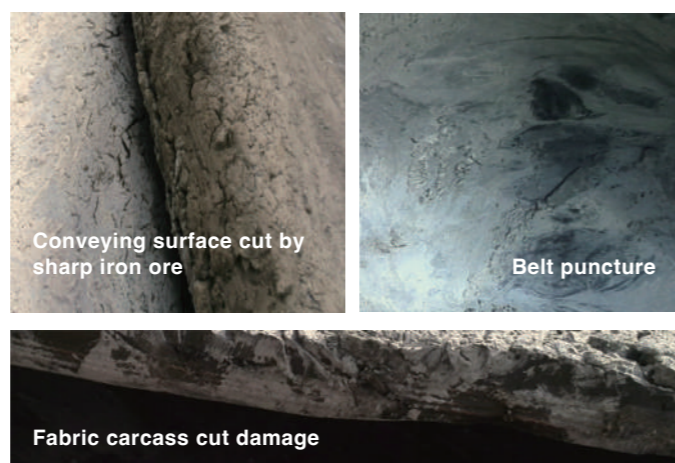
Priority should be given to selecting a fabric carcass structure featuring enhanced design for transverse tear resistance and anti-puncture performance. Refer to the table for the impact resistant series fabric carcass weave structure for details.

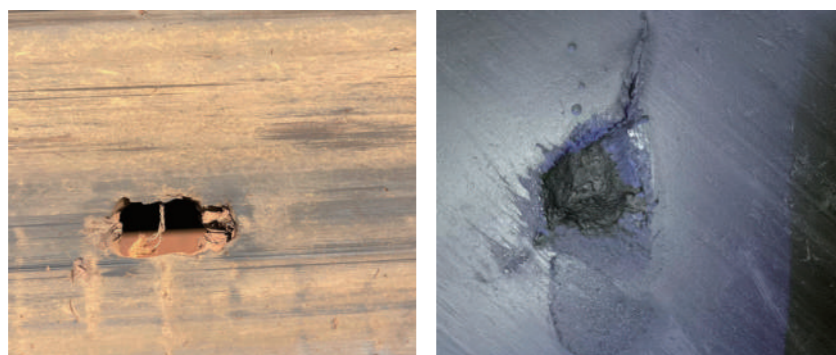
Under frequent impact or the action of sharp materials, the cover rubber layer can be broken through, leading to carcass exposure, rubber layer peeling (stripping), or even the formation of penetrating holes under heavy pressure.

The selection of cover rubber specially designed for enhanced toughness can effectively improve the conveyor belt's resistance to cutting.
